CONFEDERACIÓN
HIDROGRÁFICA
DEL TAJO

COFIO RIVER RESTORATION AND DAM REMOVAL IN ROBLEDO DE CHAVELA (MADRID, SPAIN)

The dam was located in Cofio river (belonging to Tajo river basin).

It was built for supplying purposes during the early sixties, but few years later it became unusable, due to water quality problems.

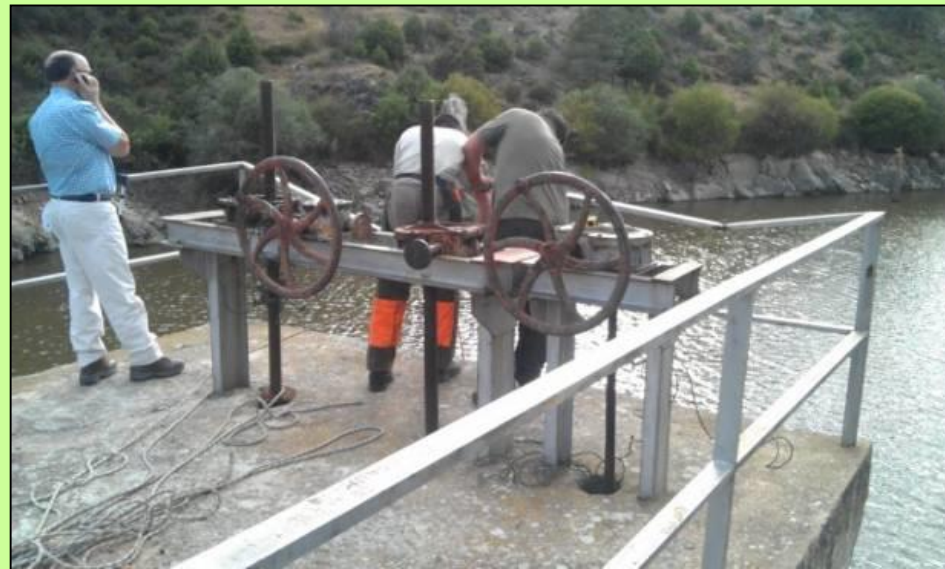
On June 8th, 2012, the Tajo River Basin Authority detected a water leak from the spillway impossible to repair and, consequently, launched urgent measures to avoid an extreme fish death in the reservoir and sediment transport downstream

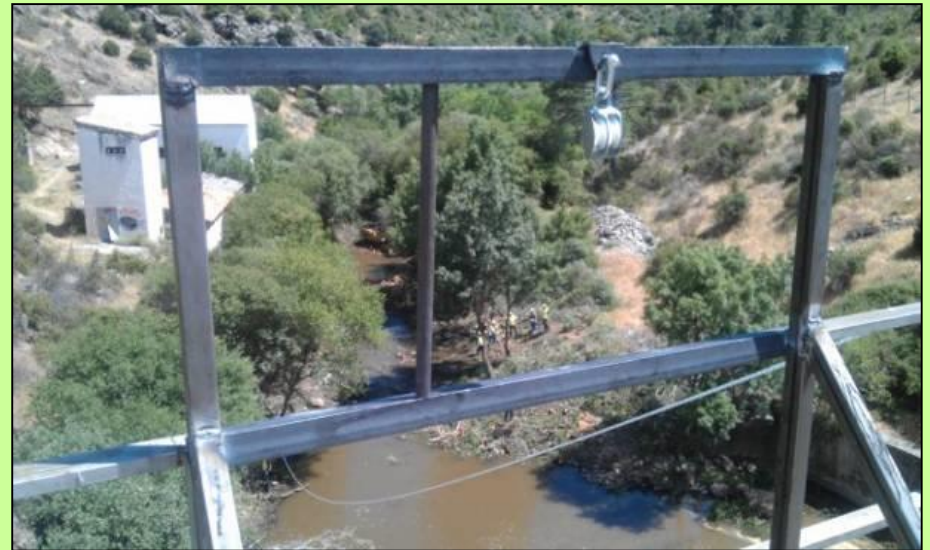
Sounding line sampling to count fish
population density and sediments
thickness

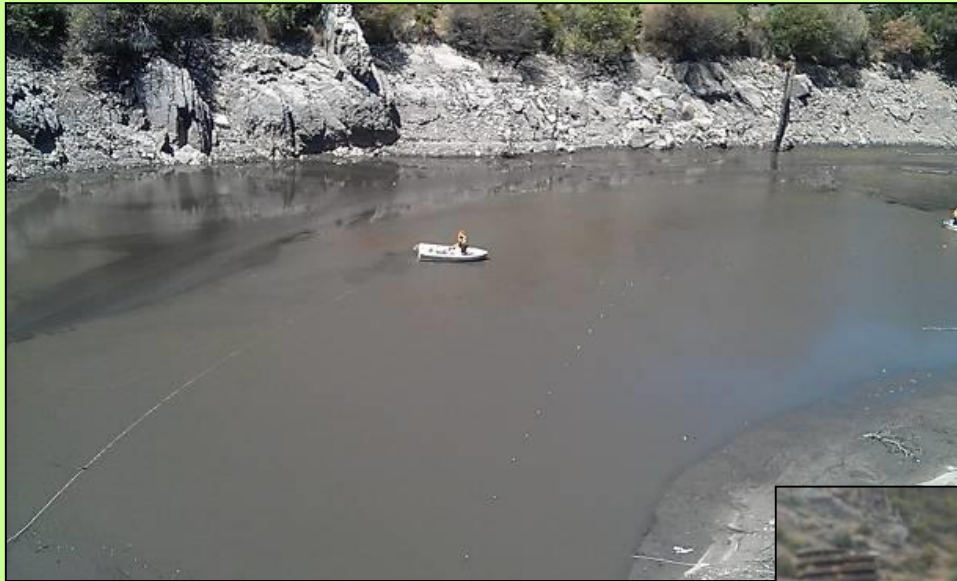
Zip-line for fish transfer from the empty
reservoir to downstream

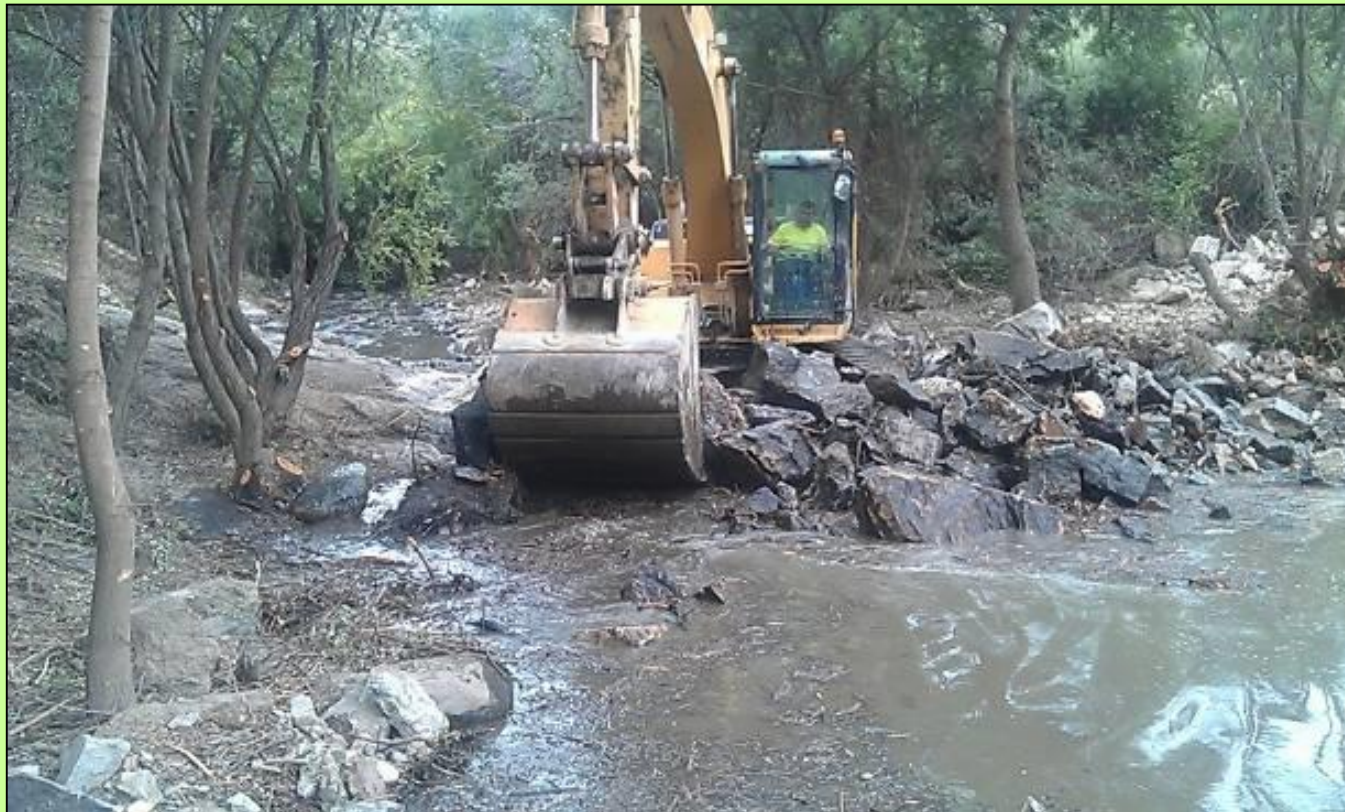
DIKES CONSTRUCTION TO AVOID SEDIMENTS TRANSPORT DOWNSTREAM

1st dike: 1,5 m high.

Downstream dam wall for immediate sediments retention

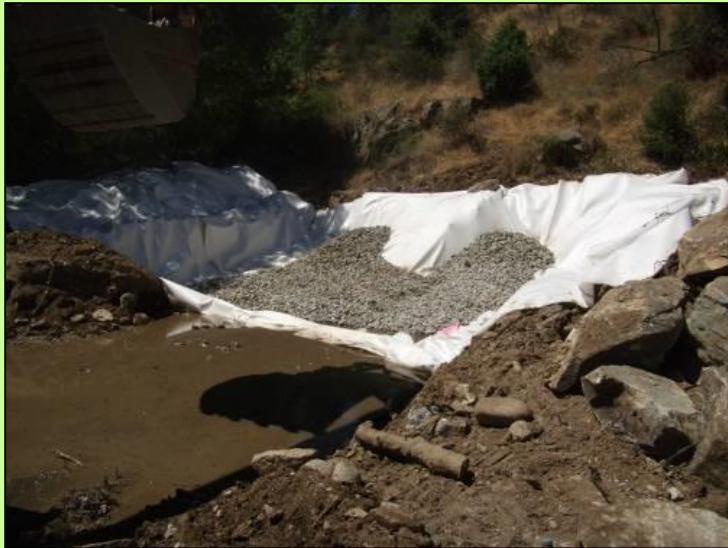
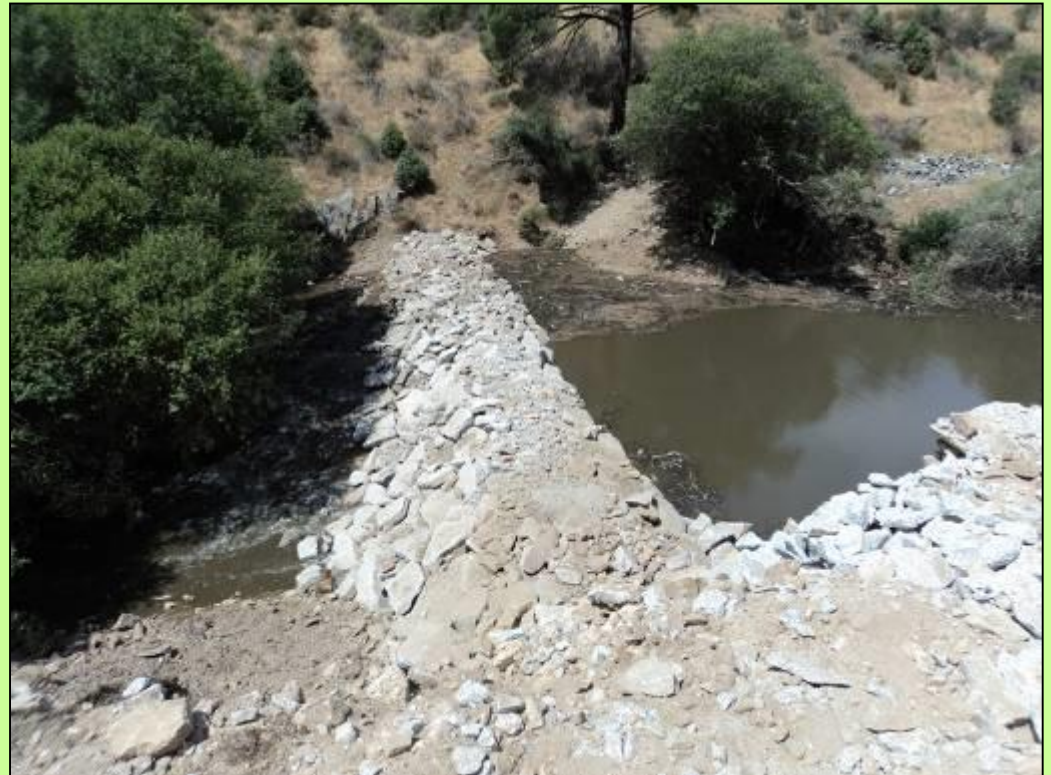
2nd dike: 3,5 m high: 150 m downstream dam wall

Gravel and geotextile sheet core

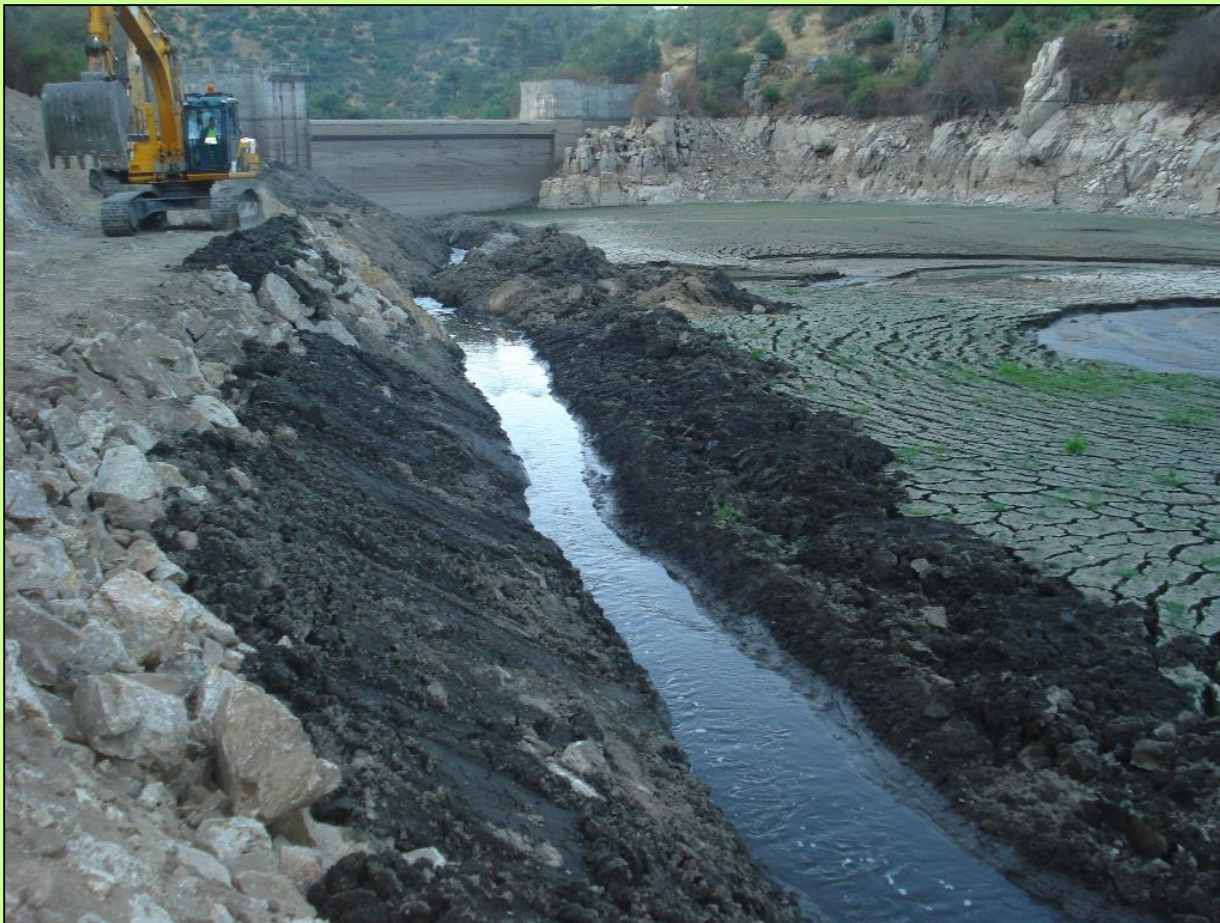
DRAINAGE IN RESERVOIR TO HELP SEDIMENTS DRY OUT

Once the reservoir was emptied, a ditch helped sediments drainage and dry out

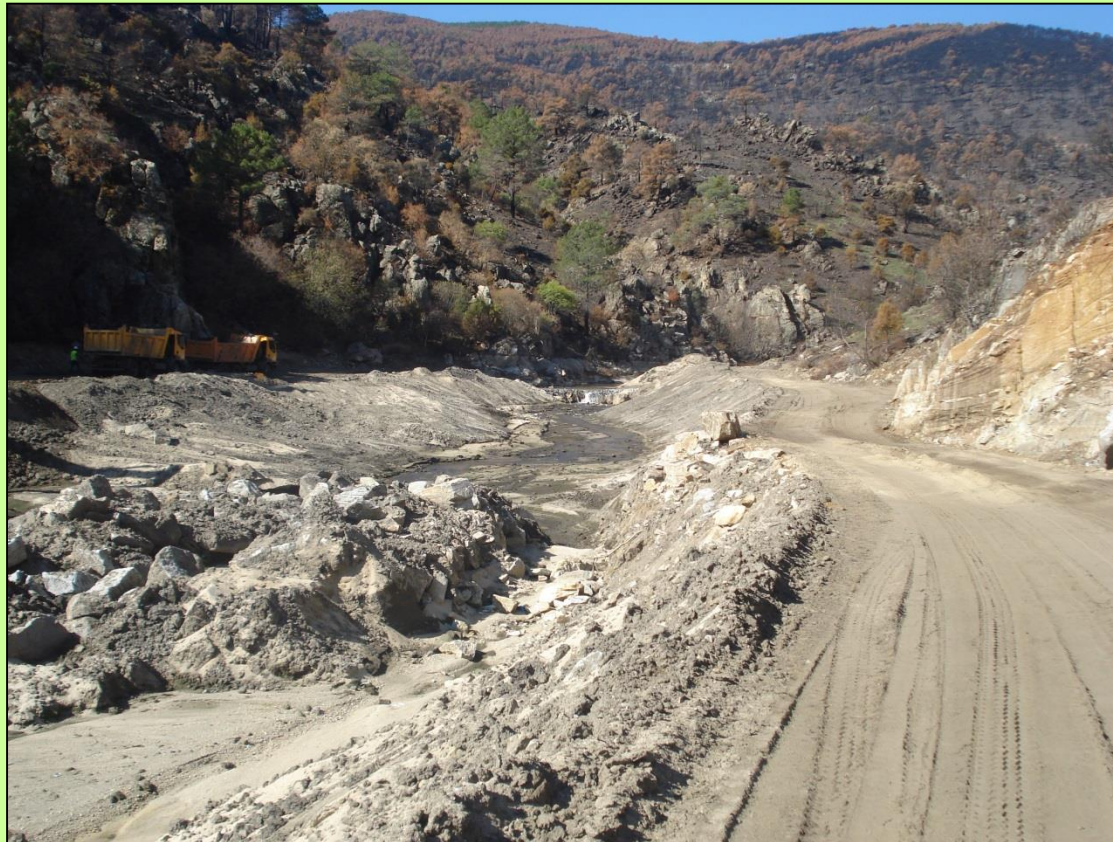
SEDIMENTOS REMOVAL AND TRANSLOCATION

Path in both sides to enter into the reservoir and remove sediments

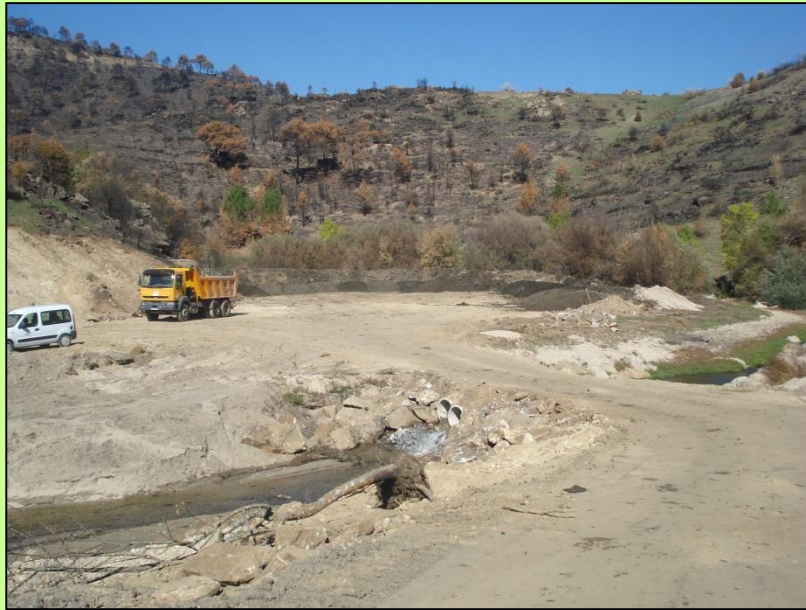
Sedimentos translocation: 300 m upstreams in a wide meander.

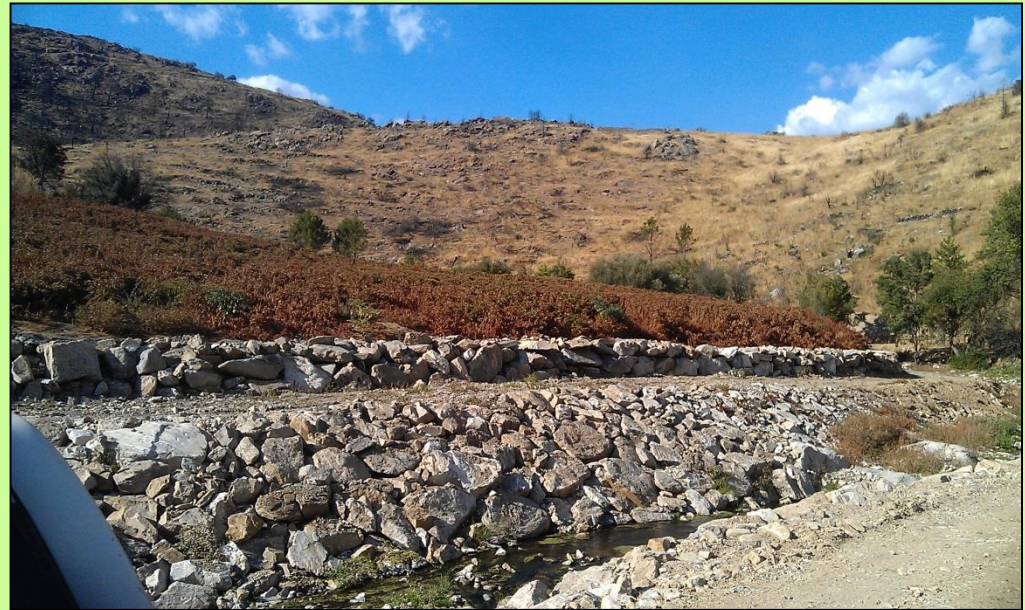
During translocation

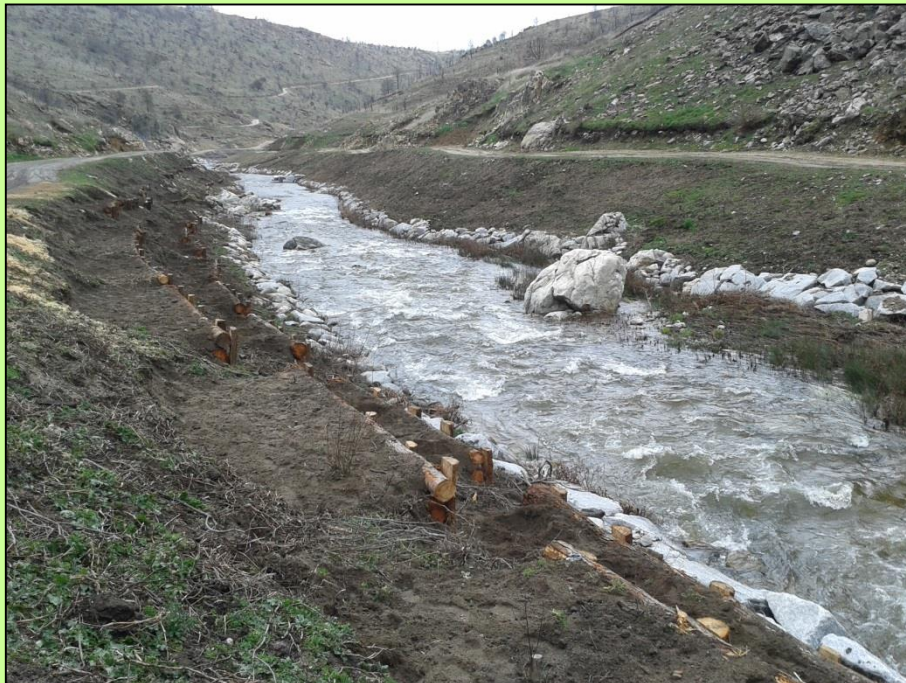
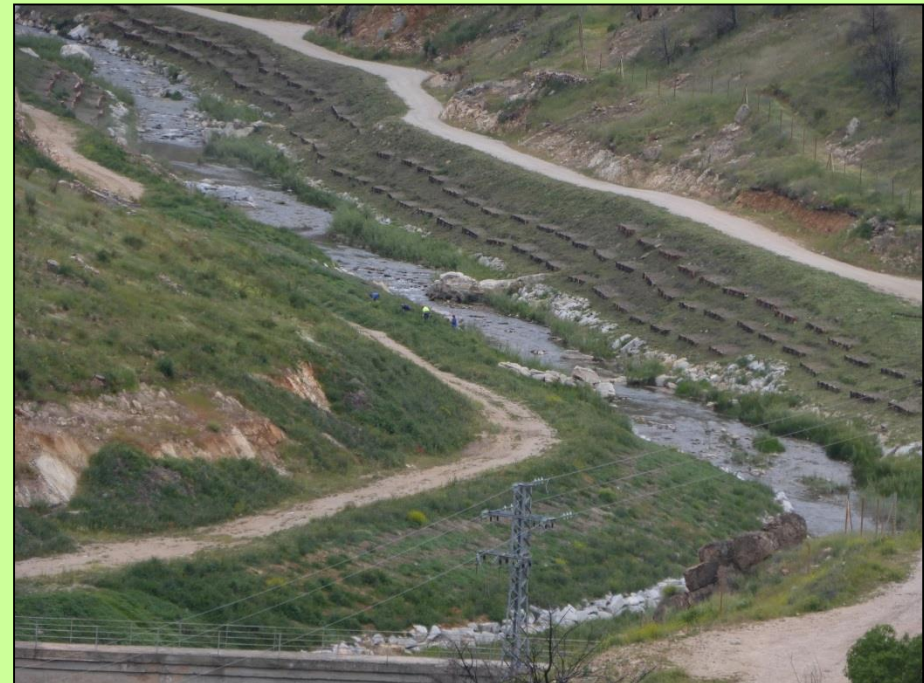
RIVER BED DELIMITATION AND BANKS PROTECTION:

Sediments removed, stone protection and plantations

Slopes were reprofiled and reinforced by a breakwater wall.

To prevent erosion, revegetation was accomplished by hydroseeding and native trees and bushes plantation

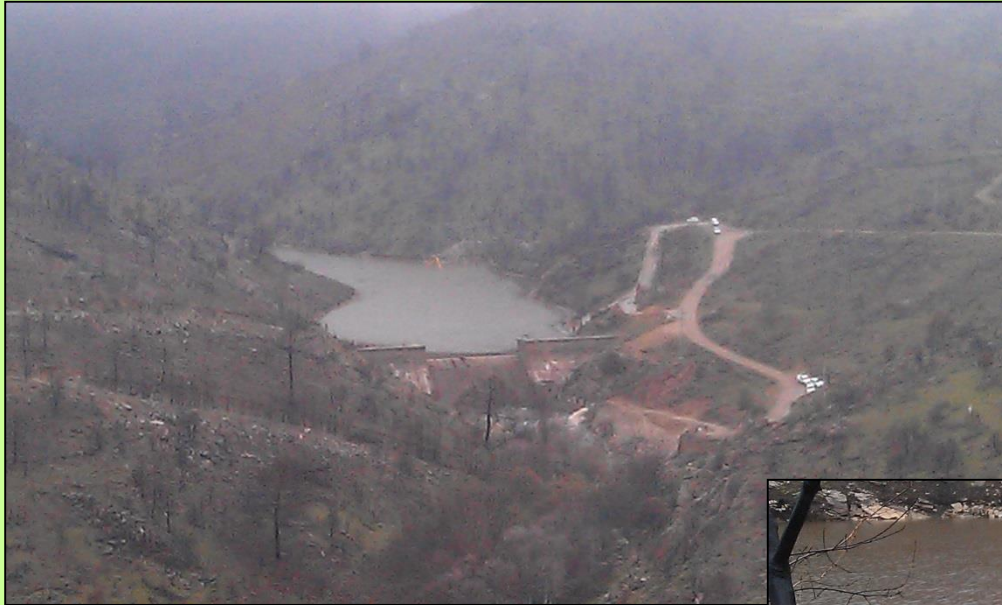
Floods in Cofio valley. March 2012

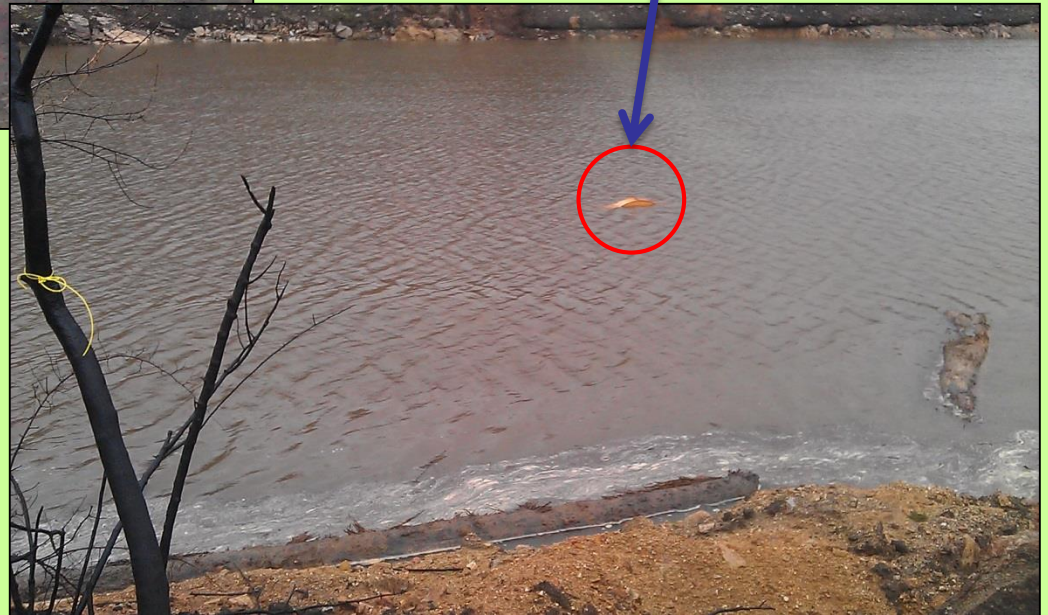
Backhoe loader
UNDER WATER

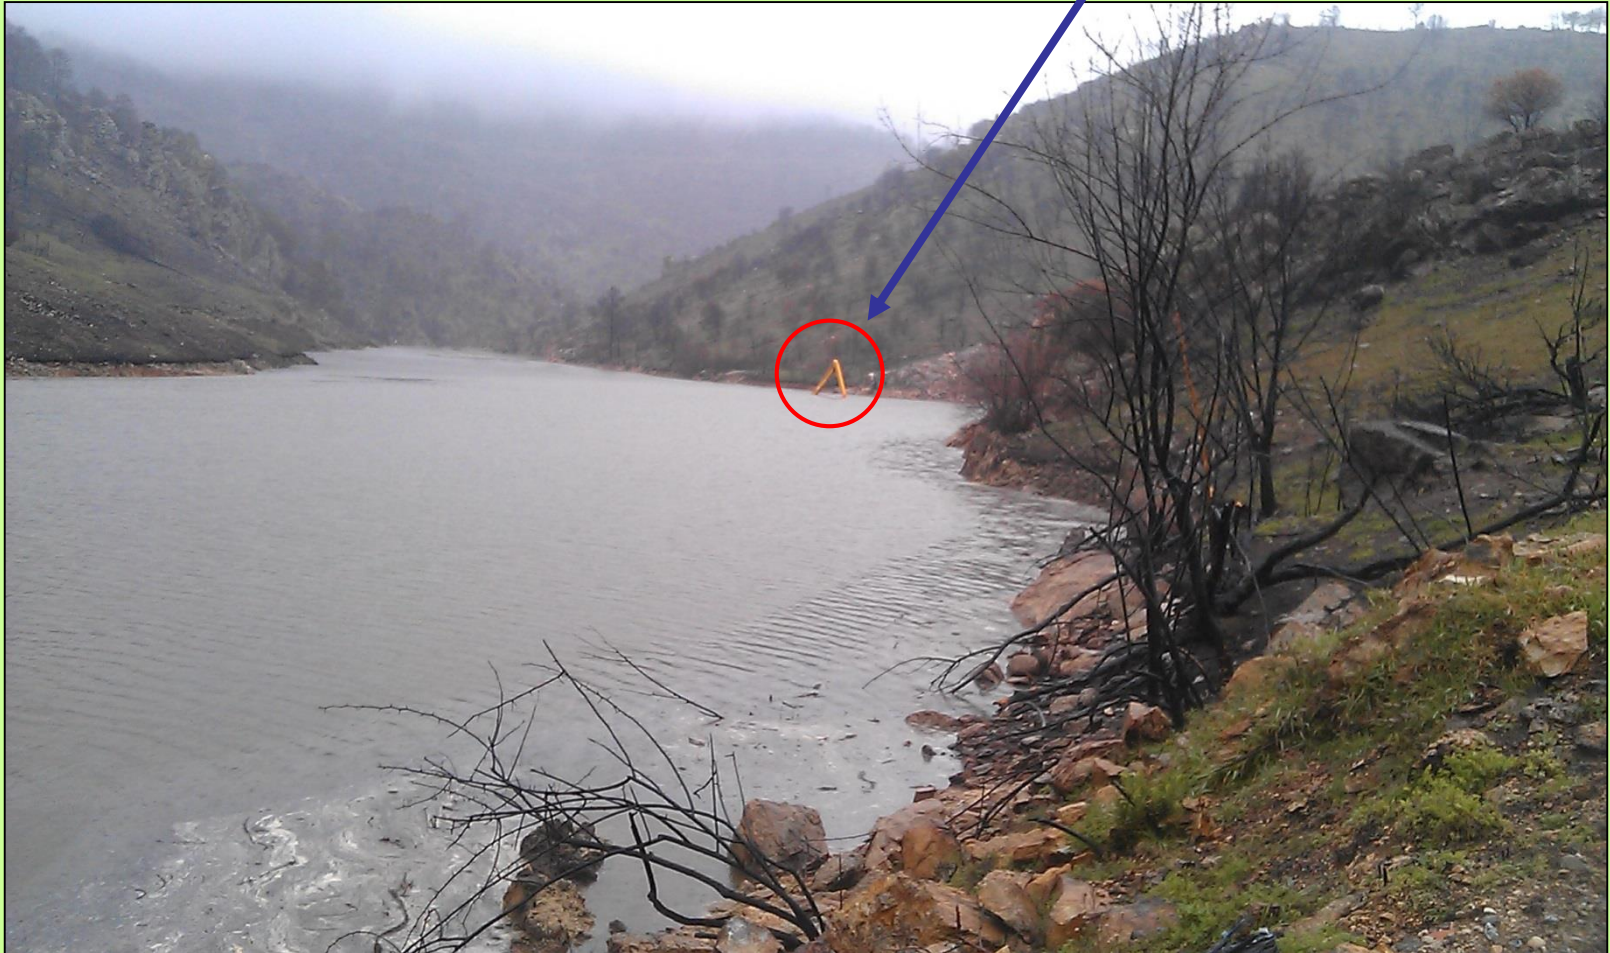
Backhoe loader
UNDER WATER

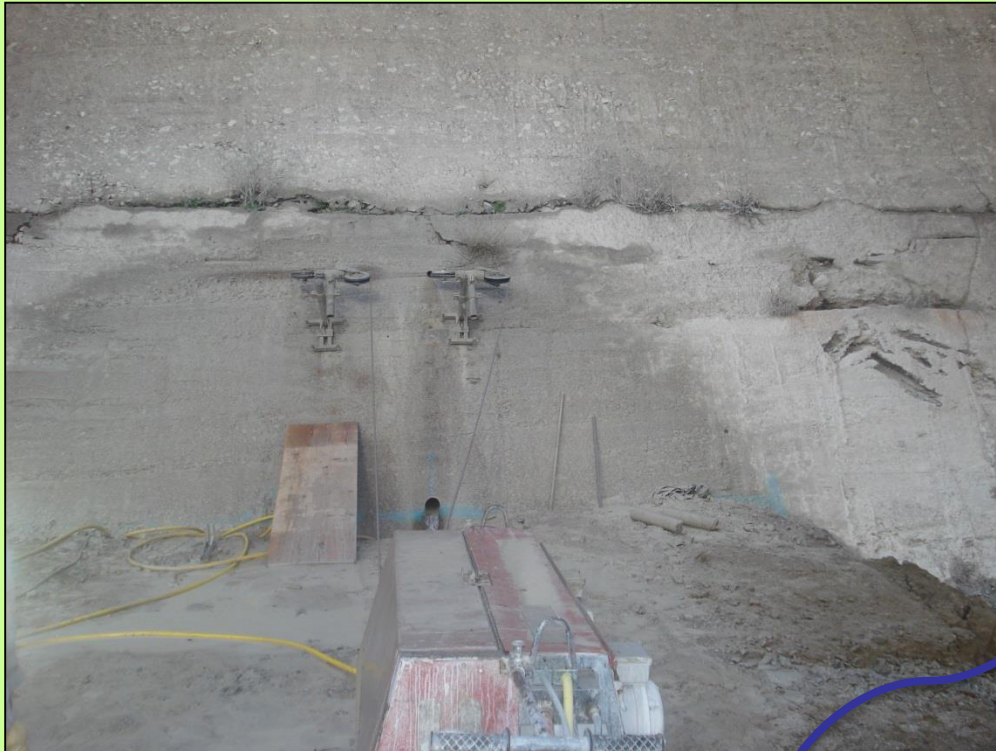
DRAIN CONSTRUCTION IN DAM WALL TO AVOID NEW FLOODS

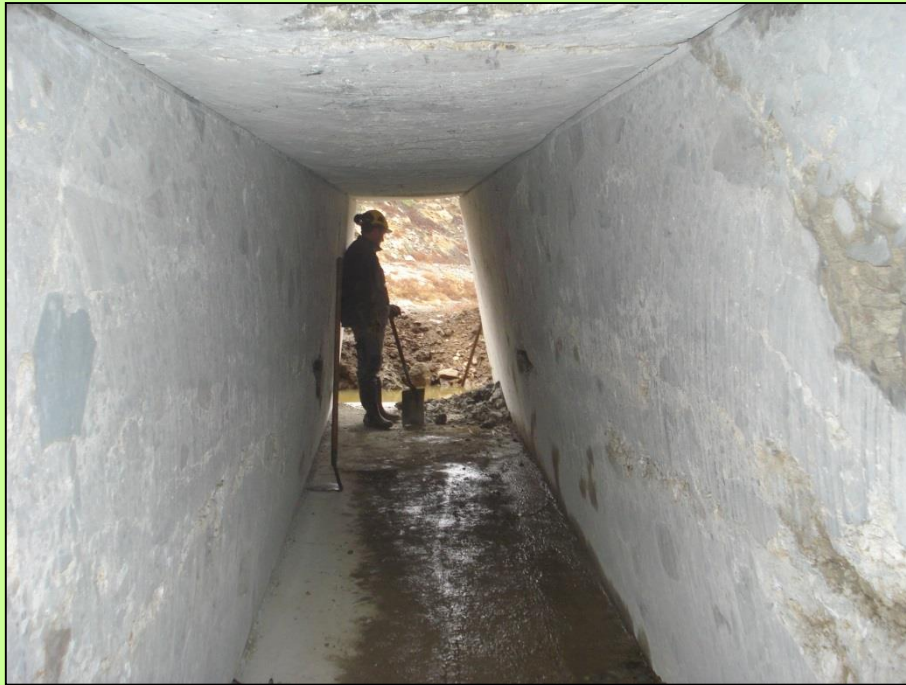
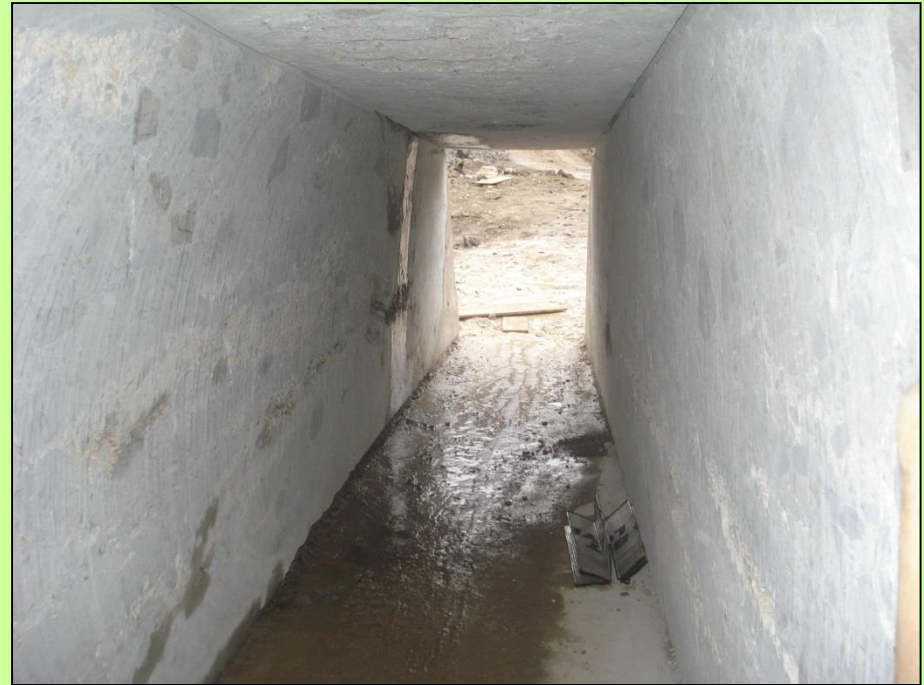
DURING DRAIN CONSTRUCTION IN DAM WALL

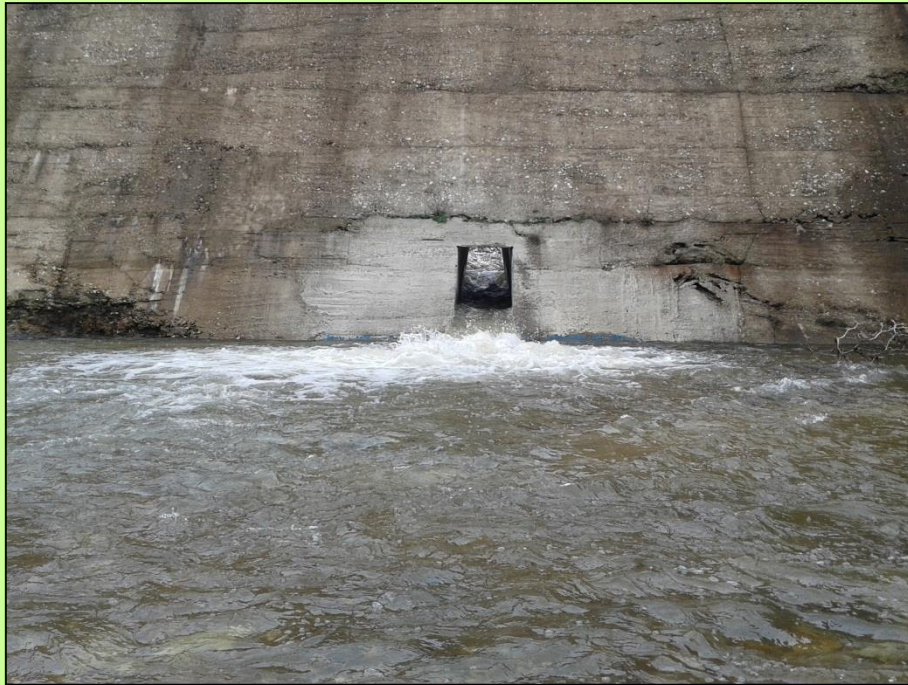
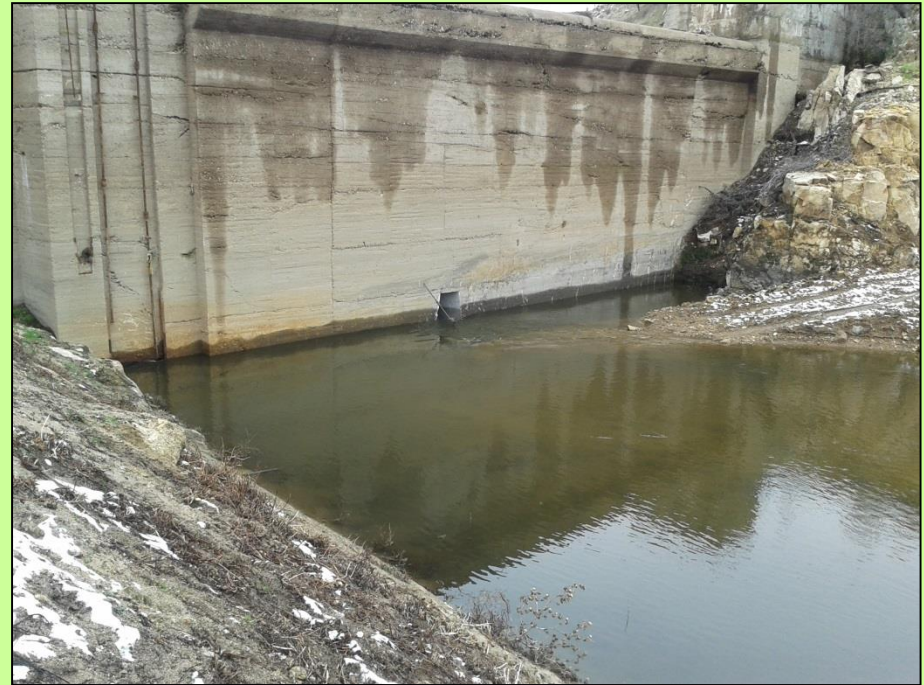
DRAIN IN DAM WALL ACCOMPLISHED

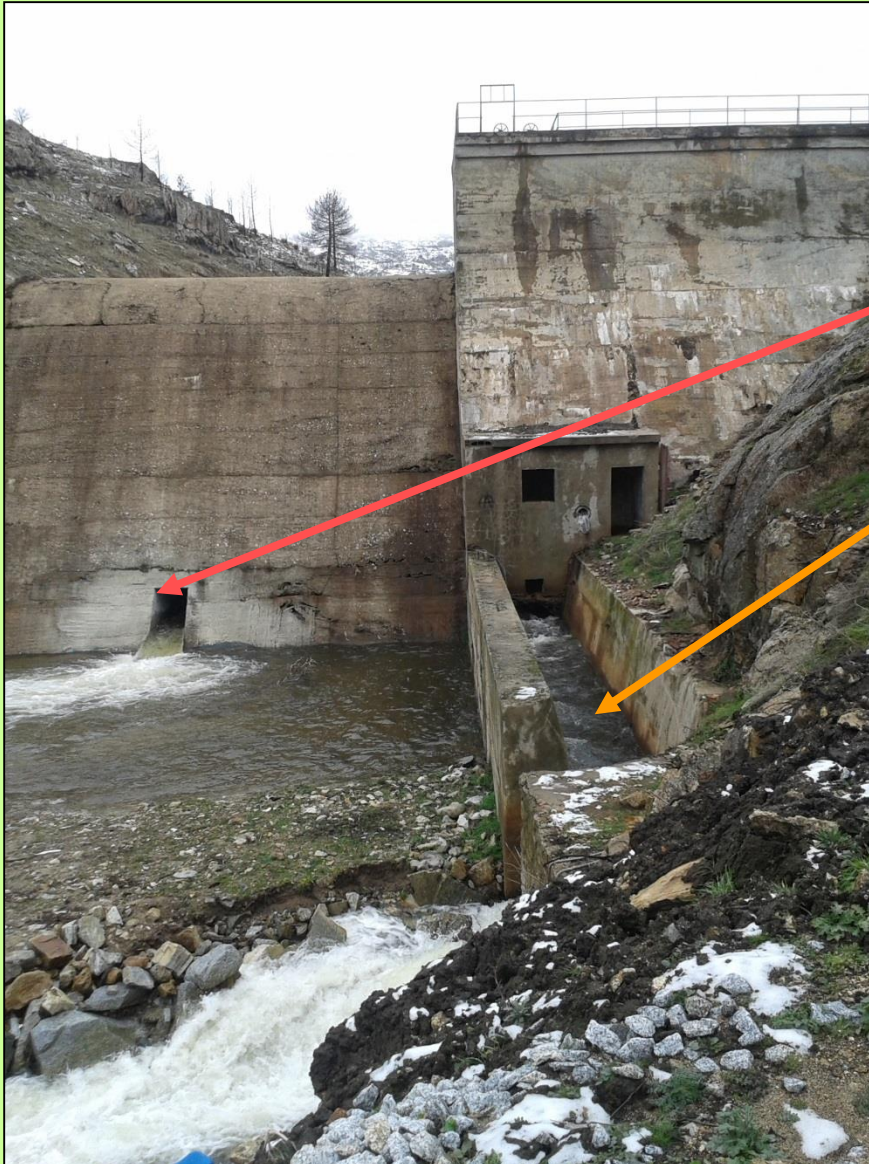
**WATER THROUGH
DRAIN AND SPILLWAY**

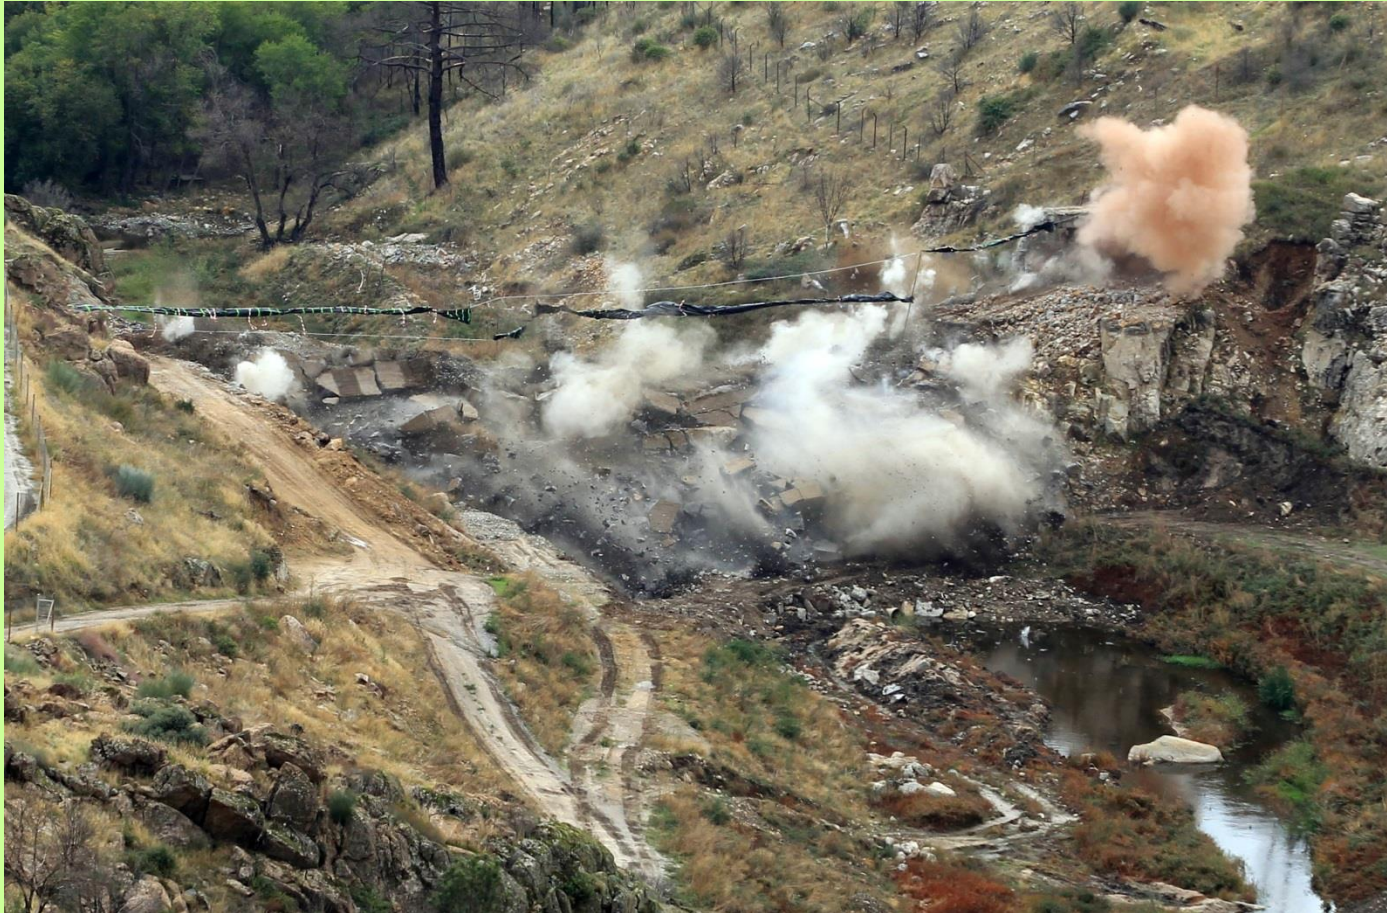
DAM REMOVAL BY DETONATION

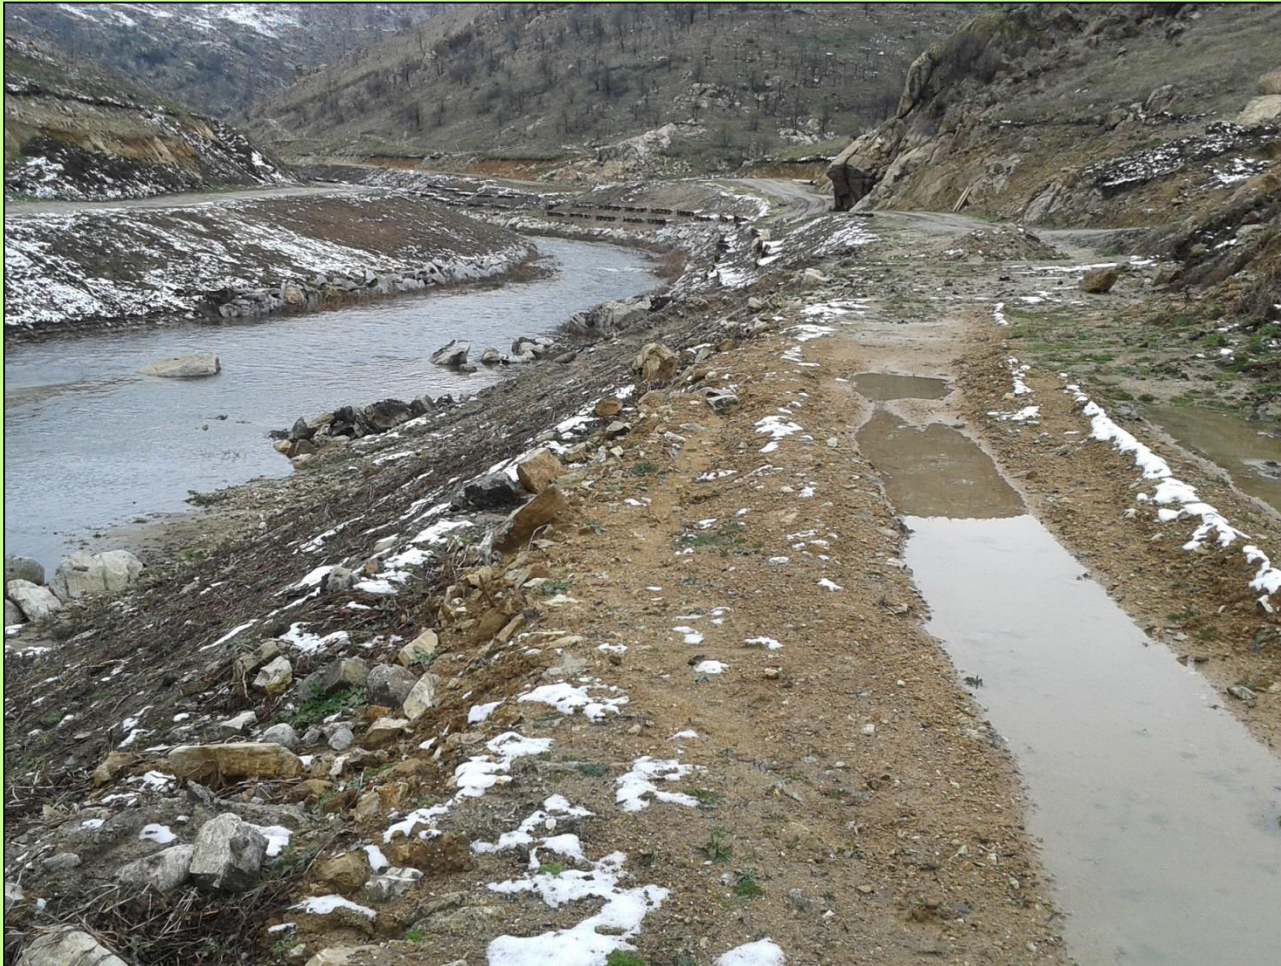
RENATURALIZATION IN THE DAM SURROUNDINGS ONCE REMOVED THE RUBBLE
